# TEMP PRODUCTS

## WHY NAPA® TEMP COMPRESSORS

#### NAPA® TEMP 10S p/n TEM 272525

### NAPA® TEMP V5 p/n TEM 274214

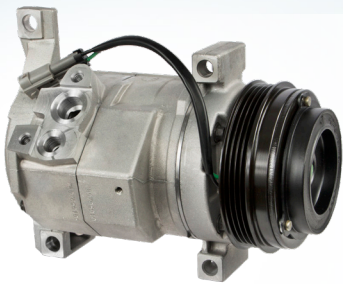
In the early 2000's, O.E. manufacturers switched their H-series compressor design to a more durable 10S design. While some suppliers maintain a 10PA version, NAPA® Temp employs an upgraded 10S design over the O.E. for the highest quality standards.

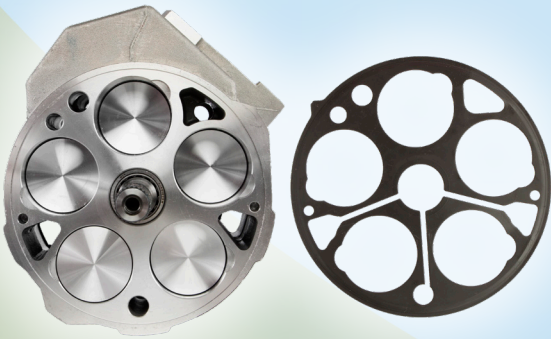
The NAPA® Temp 10S design features 4 HMBR coated gaskets to provide more sealing surface area between high and low side chambers to prevent leakage.

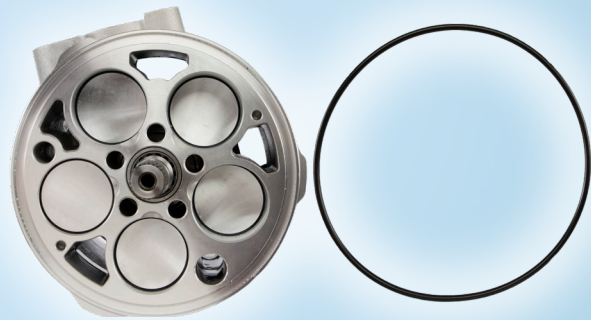
The competitor 10PA design has O-rings to seal the unit. Over time, O-rings retain memory and lose elasticity, which will lead to leakage.

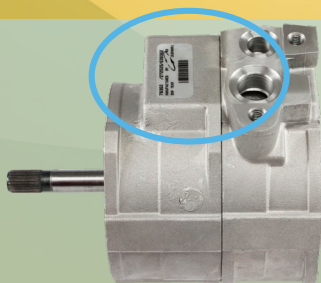
NAPA® TEMP UNIT

NAPA® Temp's unique design muffer on discharge chamber provides quieter and smoother operation by reducing pressure pulsation.

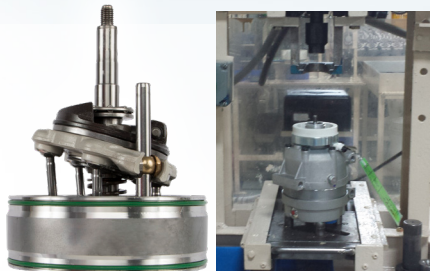
### NAPA® TEMP UNIT

Assembled to proper specs using press fit machining technology just as the O.E. unit.

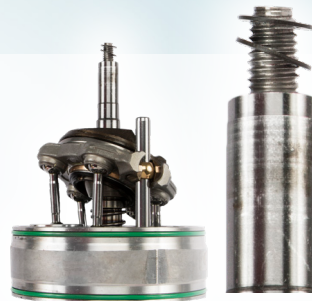
### COMPETITOR UNIT

Competitor uses shims to correct flaw in design; small shaft or hub diameter to large.

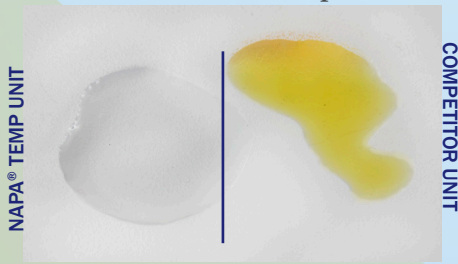
When the oil in a compressor is yellow, air and / or moisture has corrupted the unit. All NAPA® Temp new compressors are nitrogen charged to prevent moisture as shown in the competitor oil below.

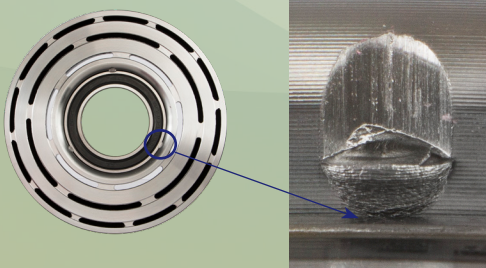
### NAPA® TEMP UNIT

Our unit is assembled to precise measurements so the stake is positioned just above the race for perfect placement and smoother ball bearing operation.

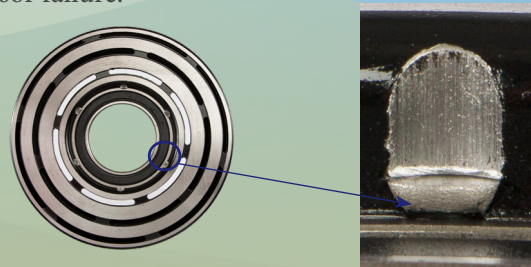
### COMPETITOR UNIT

Competitor unit shows stake smashed down, pushing metal behind bearing. Problem may not be known at first, but will eventually lead to a crack in the plastic cage that holds ball bearings, thus cause bearings to get louder and fail and ultimately catastrophic compressor failure.
